Custom Abutments Alone May Not Suffice in Overcoming Negative Clinical Effects of Poor Cementation Technique

Alfonso Piñeyro, DDS; and Jeffrey Ganeles, DMD

Abstract: With proper planning, placement, prosthetic treatment, and maintenance, dental implants have been shown to be a predictable and reliable treatment option with a high success rate. Clinicians who place cement-retained implant restorations, however, should be aware of the potential and sometimes irreversible biological complications associated with residual excess cement and should be prepared to consider using different practices that may reduce the problem. The present case reports describe the use of custom abutments to restore deeply placed implants with the intent of minimizing residual excess cement.

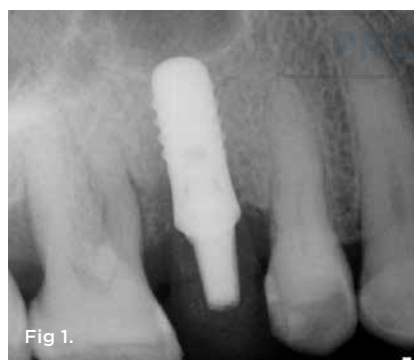
A healthy 70-year-old woman with increasingly deep pockets and furcation involvement of her upper right first molar was referred to a periodontist by her general dentist. Following evaluation and consultation, it was determined that the tooth was non-salvageable¹² and required extraction and replacement with an implant-supported crown (Figure 1).

Fig 1. Preoperative periapical radiograph showing advanced periodontal bone loss and furcation involvement on upper right first molar. **Fig 2.** Periapical radiograph of healed maxillary first molar implant. **Fig 3.** Periapical radiograph following restoration with cemented crown using a stock abutment. Radiopacity of cement was not highly visible possibly due to a change in beam angulation. **Fig 4.** Periapical radiograph of grafted socket following implant removal. **Fig 5.** Periapical radiograph of new implant in first molar site.

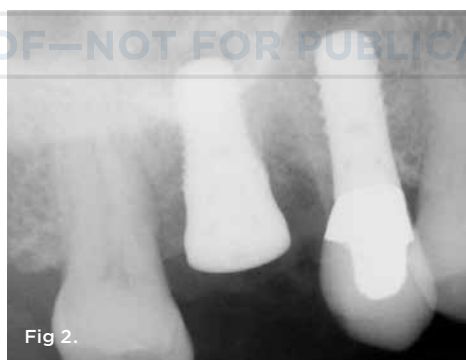
healing, the implant was restored by the patient's prosthodontist using a stock Straumann 5.5-mm WN solid abutment and a polycarboxylate-cement-retained ceramo-metal crown (Figure 2).

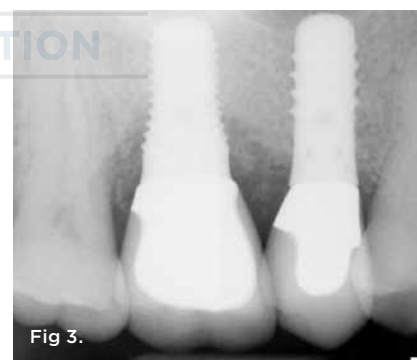
Approximately 1 year after implant placement, the patient returned to the periodontist for evaluation of 10-mm to 12-mm pockets around the mesial and palatal surfaces of the implant (Figure 3), an indication of the presence of an advanced peri-implantitis lesion.¹⁴ During surgical debridement of the area, large amounts of subgingival cement were found on the palatal surface of the implant, which was associated with 6 mm to 8 mm of bone loss extending from the mesio-palatal to the disto-palatal line angles. There was little involvement of the proximal or buccal surfaces. The area was debrided and the implant was treated with saturated citric acid for 1 minute, followed by grafting with FDBA and Emdogain™ (Straumann). Healing appeared to proceed uneventfully; however, due to the patient's traveling schedule, only one follow-up with the periodontist was possible.

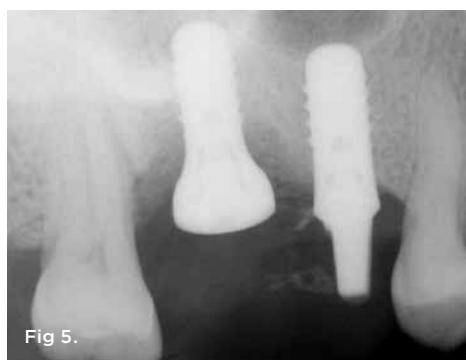
Approximately 9 months following the repair procedure, the patient was again referred back for evaluation of bleeding and suppurating pockets of 9 mm to 10 mm on the mesial and palatal of implant No. 3. In consultation with the patient and a new restorative dentist, it was determined that the repair procedure had failed and removal of the implant was necessary. Implant removal was performed after undermining the integrated implant surfaces with a high-speed bur and copious irrigation in conjunction with counter-rotation

with extraction forceps. Grafting of the defect was accomplished using an allograft putty (Regenaform®, Exactech Inc., www.exac.com) reconstituted with venous blood beneath a collagen barrier (Bio-Gide®, Geistlich Pharma North America, Inc., www.geistlich-na.com). The buccal flap was advanced to obtain primary closure (Figure 4). Since the patient did not want to be "toothless," the ceramo-metal crown on No. 4 was removed, and a cantilever provisional on Nos. 3 and 4 was cemented.

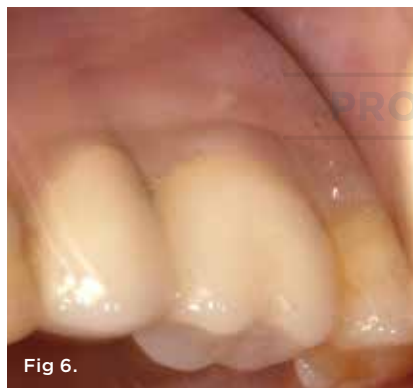
Upon the patient returning to the periodontist for routine supportive care 6 months after cementation of the new crown, pockets of 5 mm to 6 mm were noted circumferentially around the implant, with significant bleeding on probing and a buccal fistula (Figure 6). A periapical radiograph revealed a large

Fig 6. Mirror view of restored replacement implant with buccal fistula draining near the mucogingival junction. **Fig 7.** Radiograph taken at appointment when fistula was observed. Note radiopaque material on mesial apical to the implant-abutment interface. **Fig 8 and Fig 9.** Custom abutment with adherent, hard, yellowish and whitish material consistent with REC. **Fig 10.** Periapical radiograph 1 year following REC removal showing intact crestal bone levels and a lack of radiopaque material on the abutment.

subgingival cement deposit on the mesial (Figure 7). A treatment recommendation was made to remove the crown and abutment for thorough cleaning and to ensure there was no remaining residual cement.

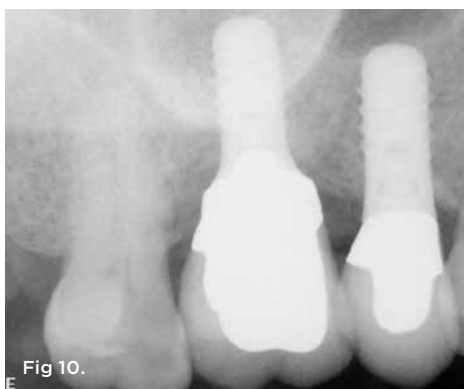
Fig 10.

One year later, the patient was seen for routine periodontal supportive treatment, and a new periapical radiograph was taken (Figure 10). At this visit, there were no clinical signs of inflammation around the implant and no radiographic evidence of bone loss or excess cement.

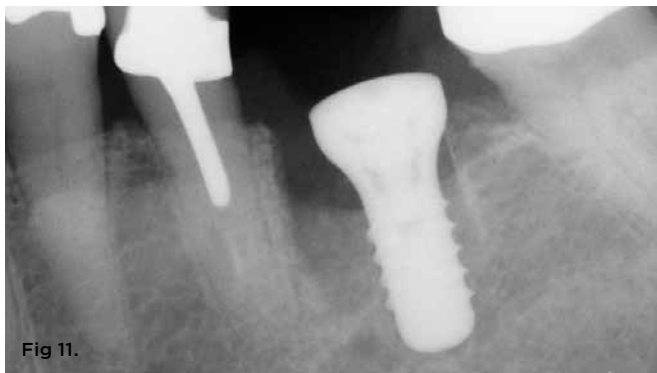
socket with autogenous bone chips and anorganic bovine bone (BioOss®, Geistlich) without loading (Figure 11). Healing proceeded uneventfully, and the implant was restored 4 months later by the patient's restorative dentist with a custom cast abutment under a ceramo-metal crown. The patient returned to the periodontist for annual follow-up, at which time it was noted that she had erythematous and edematous gingiva surrounding the implant, with sup-puration and pockets measuring 8 mm on the direct facial (Figure 12). Radiographs taken to evaluate the condition showed relatively normal bone levels on the implant with nothing unusual about the restoration (Figure 13).

Fig 11. Periapical radiograph taken 4 weeks following implant placement. **Fig 12.** Mirror view of inflamed bleeding tissue probing 7 mm on the facial, 1 year after implant placement. **Fig 13.** Radiograph taken 1 year following implant placement showing good bone levels with a slight open margin on the distal between the crown and custom abutment.

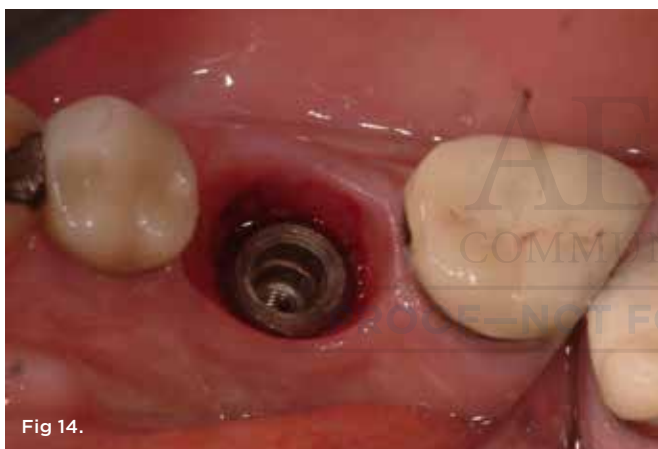
The crown was removed with a crown remover (GC Pliers) and the abutment was unscrewed from the implant (Figure 14). The abutment had a thick coating of material, presumably cement, extending into the surrounding gingival sulcus (Figure 15 and Figure 16). After mechanically removing the material from the abutment and then cleaning it ultrasonically, the abutment was re-placed in the implant and retorqued to 35 Ncm. The ceramo-metal crown was then carefully recemented (Durelon). Follow-up examination showed spontaneous resolution of inflammation and restoration of sulcus depth of 3 mm to 4 mm circumferentially.

Fig 14. Clinical view after removal of the custom abutment showing inflamed peri-implant mucosa. **Fig 15 and Fig 16.** Custom abutment with hard, adherent material surrounding transmucosal portion.

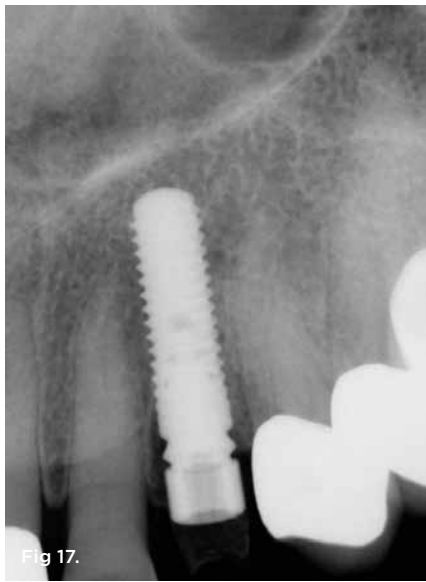
Fig 17. Periapical radiograph taken immediately after placement showing implant 2-mm subcrestal with an immediate provisional. **Fig 18.** Periapical radiograph of healed implant 3 months after placement with crestal bone level with the head of the implant. **Fig 19.** Radiograph taken 9 months following restoration placement with two threads of crestal bone loss, but no radiographic evidence of excess cement.

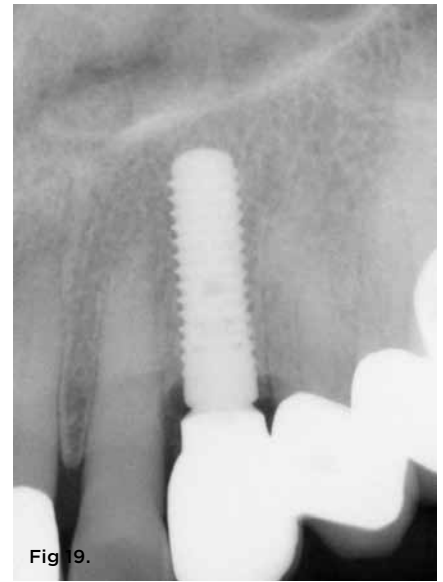
Fig 19.

Thirteen months following implant placement and 9 months after final restoration with a milled zirconia abutment and cemented ceramic crown, the patient returned to the periodontist complaining of vague discomfort and occasional bleeding from the tissue around the implant. Pocket depths of 5 mm to 6 mm with bleeding on probing were noticed, as was evidenced by 2 mm of radiographic crestal bone loss (Figure 19 and Figure 20). Although the radiograph did not suggest the presence of cement, it was believed that some residual luting material was clinically detectable in the pockets surrounding the crown. (Note: Although no radiograph was taken at the time of implant placement, the 2 mm of bone loss refers to a comparison to the time of final healing when the patient was released back to the restorative dentist for final restoration. While the authors acknowledge that this is not absolute proof that the bone loss occurred following final restoration, they believe it is strong circumferential evidence.)

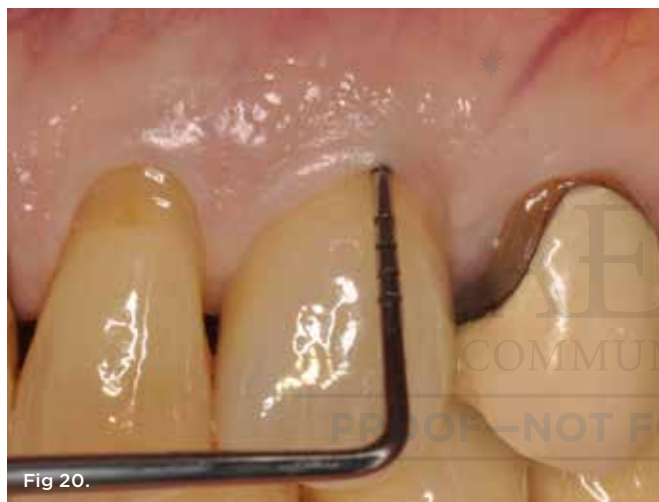
Fig 20. Clinical photograph showing 5 mm probing depth. **Fig 21.** Initial flap reflection showing ring of cement adjacent to zirconia custom abutment. **Fig 22.** Cement removed from around the implant, with bevel of the top of the implant visible. **Fig 23.** Clinical view following cement removal showing extensive circumferential bone loss despite meticulous abutment and restoration design.

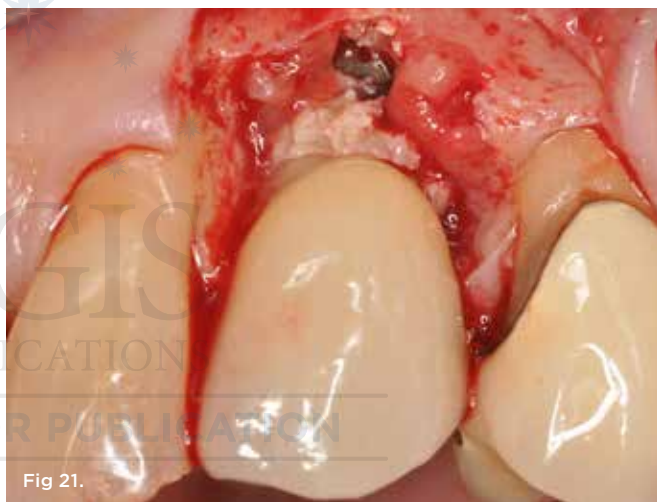
Fig 21.

After administration of local anesthetic, a full-thickness flap was raised to gain access to the implant at the abutment/restorative interface (Figure 21), which revealed a significant amount of hard, easily dislodged material consistent with excess resin cement (Figure 22). This material even had the impression of the exterior level of the implant as well as the abutment on its inner surface. After carefully removing the cement and associated granulation tissue, a 3-mm to 4-mm circumferential bony defect was observed (Figure 23). The implant was cleaned with saturated citric acid and the flaps replaced. After healing, 1 mm to 2 mm of recession was noted, but the inflammation resolved.
